ME1000-10-BRK INTERNAL COMBINATION VALVE BONNET REPAIR KIT

ME1000-10-BRK

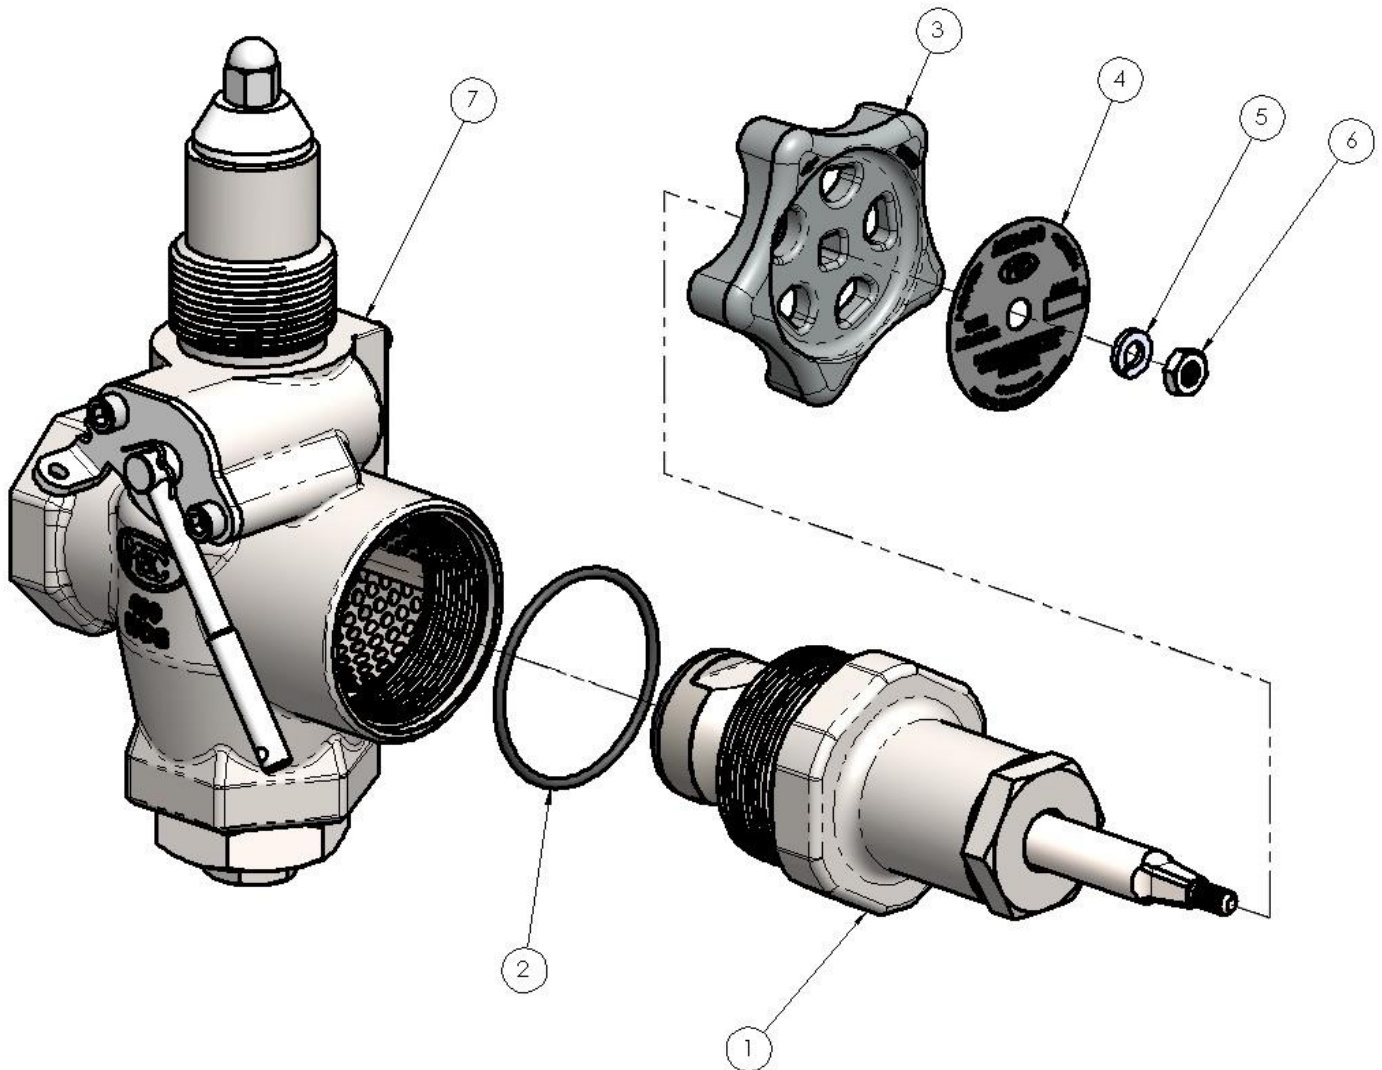
NOTE: Numbers in brackets [] refer to the number in the valve component list.

Item Number	Description	Qty.	Included in Repair kit
1	Bonnet	1	Yes
2	Bonnet O-ring	1	Yes
3	Handle	1	No
4	Handle Info Plate	1	No
5	Lock Washer	1	No
6	Nut	1	No
7	Body	1	No

1. Close internal valve
2. Fully open angle valve.
3. Remove Nut [6], Lock Washer [5], Handle Info Plate [4], and Handle [3] from Bonnet [1] and retain.
4. Unthread Bonnet [1] with Bonnet O-ring from Body [7] and discard.

1. Apply Lubriplate or equivalent grease to Bonnet O-ring [2]. Install Bonnet O-ring into groove of Bonnet [1].
2. Apply Loctite #242 or equivalent thread locker to Bonnet [1] threads.
3. Install Bonnet [1] into Body [7] and torque to minimum 50 ft-lbs.
4. Install Handle [3], Handle Info Plate [4], Lock Washer [5], and Nut [6] onto Bonnet [1]
