ME777-CRK POL FILLER VALVE COUPLER REPAIR KIT

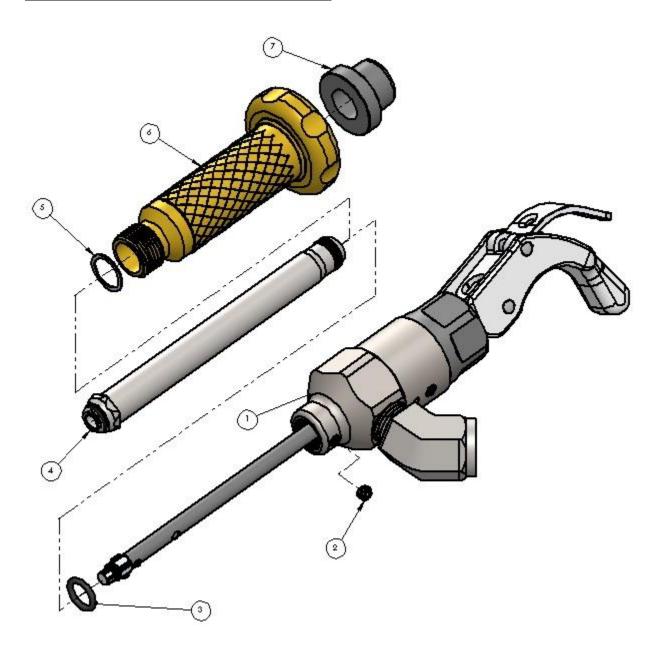
Item Number	Description	Qty.	Included in Repair kit
1	Body	1	No
2	Body Set Screw	1	No
3	Body O-ring	1	Yes
4	POL Tailpiece	1	No
5	Bearing	1	Yes
6	POL Nut	1	Yes
7	Bushing	1	No

- 1. Fully open valve.
- 2. Remove Body Set Screw [2] from Body [1] and retain.
- 3. Unthread POL Tailpiece [4], remove Bushing [7] and
- 4. Remove Bearing [5] and POL Nut [6] and discard.
- 5. Remove Body O-ring [3] and discard.

- Apply Lubriplate or equivalent grease to Body O-ring
 Install Body O-ring into Body [1].
- Install Bearing [5] and POL Nut [6] onto POL Tailpiece
 [4].
- Install POL Tailpiece [4] into Body [1] and torque to 50 ft-lbs
- Install Body Set Screw [2] into Body [1] and torque to 50 in-lbs.
